# PARKLAND COMMUNITY CENTRE - PARK96

## Parkland Community Centre Reserve Fund Study

October 25, 2024

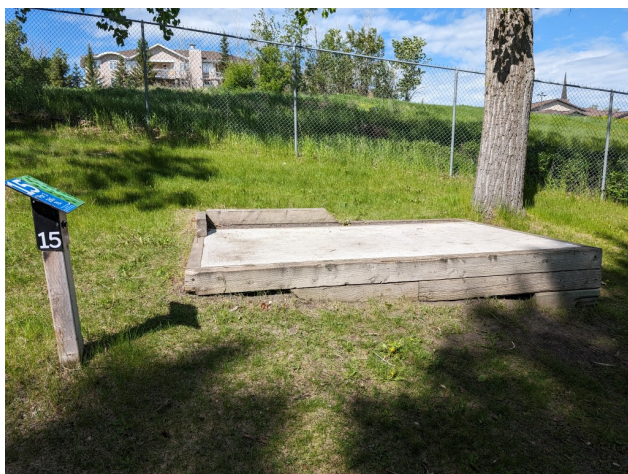
View of Disc Golf Tees

- **Disc Golf:** Tees are in good condition and expected to last for at least 15 years. However, potential operational or layout changes may necessitate earlier replacement. The elevated concrete and timber disc golf tees appear structurally sound. While the low PT timber retaining walls and concrete slab tops show minimal wear, erosion and minor undercutting of fill material around some tees were observed and should be filled. PT wood has a typical serviceable life of 10-40 years.

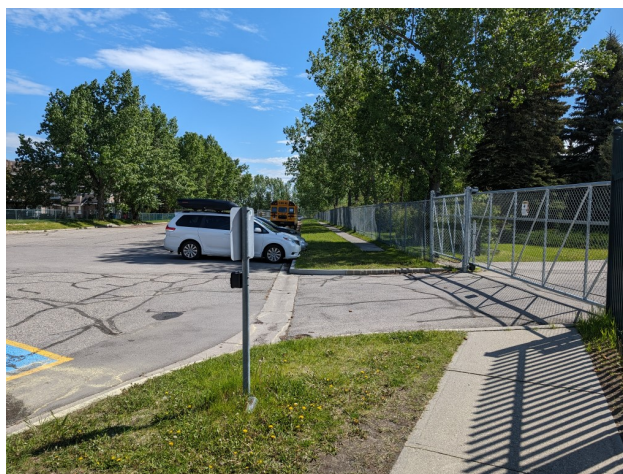
View of Sidewalks

- **Concrete Sidewalks:** The concrete sidewalks adjacent to the main parking lot are in good condition overall. However, they should be regularly inspected for potential issues such as heaving due to tree roots or soil settlement. Surface damage should also be assessed and addressed as needed. A section near the main gate is missing, and lacks curb cuts which may require attention during future improvements. Concrete sidewalks have a serviceable life of 25-50 years in typical conditions. Replacement in 20 years is expected, but could extend beyond.

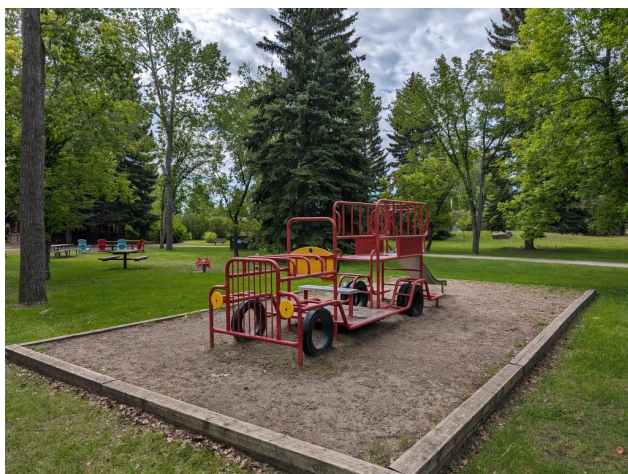
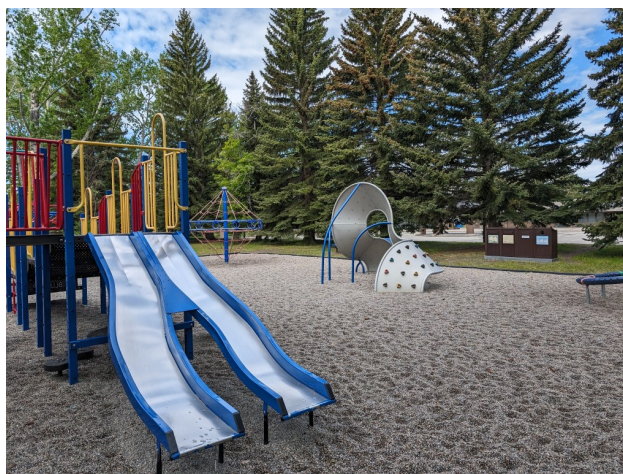
View of Playground

- **Swingsets:** Existing swingsets are in good condition, with functional seats, chains, and hardware. However, they utilize an older design that may raise safety concerns compared to modern standards. Regular maintenance, including hardware replacement and seat/chain refurbishment, will extend their serviceable life. Complete replacement is anticipated within 10-15 years to address component failures, safety concerns, and incorporate current play designs.

- **Red Steel Car Set:** This steel tube structure with rubber tires and limited composite elements is in fair condition. Regular maintenance tasks like repainting and hardware replacement are recommended to maintain its functionality. While not expected to fail immediately, it will likely require sequential replacement over the next 10-15 years as play standards evolve and wear necessitates updates.

- **Yellow Plastic and Pipe Set:** This steel tube structure with yellow composite panels and red slides is in good condition and should remain functional with regular maintenance. Like other equipment, it's expected to be replaced within 10-15 years as play standards and designs advance.

- **Timber Tire Swings:** These swings consist of timber posts, steel horizontals, and chain-supported tires. They are currently in good condition. Regular maintenance will ensure their longevity, but they will likely be replaced within 10-15 years as play trends change and equipment ages.

- **Blue Pipe Set, Climber, Spinner:** This predominantly steel pipe set with curved stainless steel climbers and some nylon rope components is in excellent condition. Regular maintenance will extend its lifespan; however, it's anticipated to be sequentially replaced within 10-15 years as play standards evolve.

- **Playground Gravel and Edging:** Playgrounds feature pea gravel surfaces with timber or composite edging. This surface is currently in good condition. However, regular maintenance is needed to address infiltration of dust and organic material into the gravel. Replacement of both gravel and edging is projected for year 20, addressing worn components and disposal concerns.

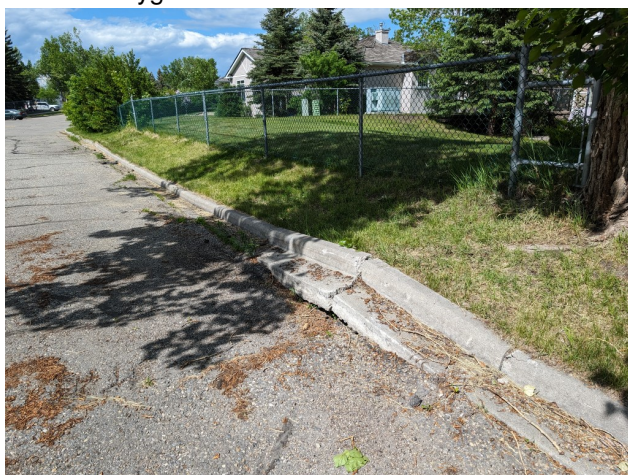
View of Parking Lot Curbs

- **Concrete Curb & Gutter:** The concrete curb and gutter surrounding the parking lot is in poor to moderate condition with localized failures attributed to tree root heaving. Though the concrete itself remains generally serviceable, grade separation between the gutter and paving exists, along with surface damage from vehicle impacts. Replacement of the curb and gutter is recommended concurrently with asphalt resurfacing to address wear, heaving, and failed areas, ensuring a cohesive and functional parking lot design.

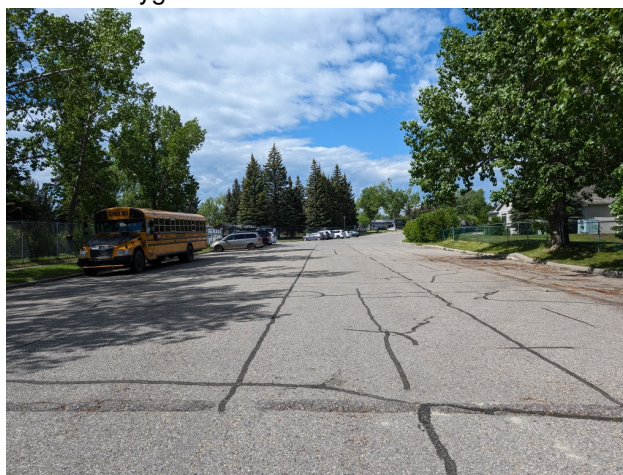
View of Parking Lot

- **Parking Lot Asphalt:** The main parking lot asphalt is in poor to moderate condition. Surface deterioration includes significant ravelling, cracking, and some mild unevenness caused by heaving and settlement. While previous crack filling efforts have been made, cracks will continue to expand. Localized tree root growth contributes to grading issues that will require addressing. Proactive measures include regular removal of organic growth and continued crack filling. However, resurfacing is anticipated within the next 10 years to effectively address the deteriorating surface condition.

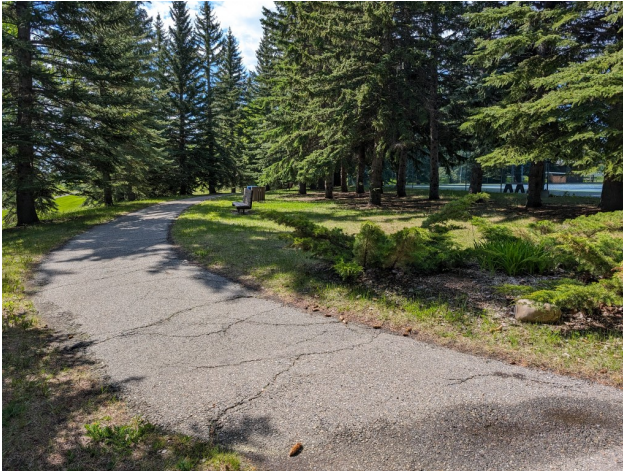
View of Pathways

- **Asphalt Pathway Resurfacing:** The asphalt pathways are in poor to moderate condition characterized by cracking, surface degradation, ponding areas, raveling edges, root heaving, and deteriorated transitions between paving and sod. Resurfacing could be undertaken at any time but we have included replacement within the next 10 years. Considering the pathway's use as pedestrian-only traffic, a complete failure scenario followed by selective gravel surfacing might be an alternative option to consider.

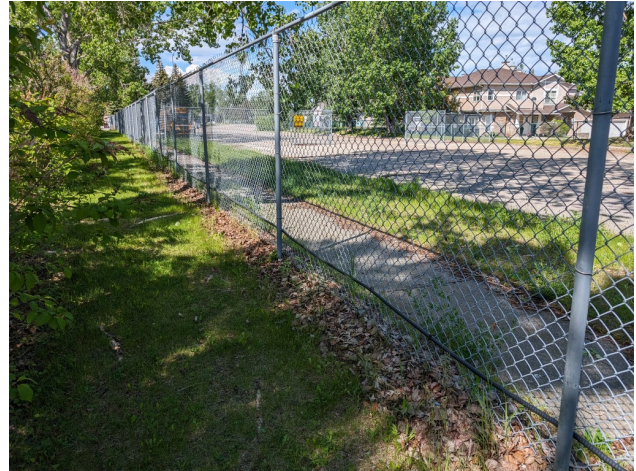
View of Perimeter Fencing

- **Perimeter Fencing:** The perimeter fencing is generally in good condition. Localized damage from tree fall has been noted and, according to information received, is being addressed through repairs. While a full replacement cost has

been included, a phased approach to replacement is recommended as the overall condition of the fence degrades. Typical chain link fencing lasts between 20-30 years.

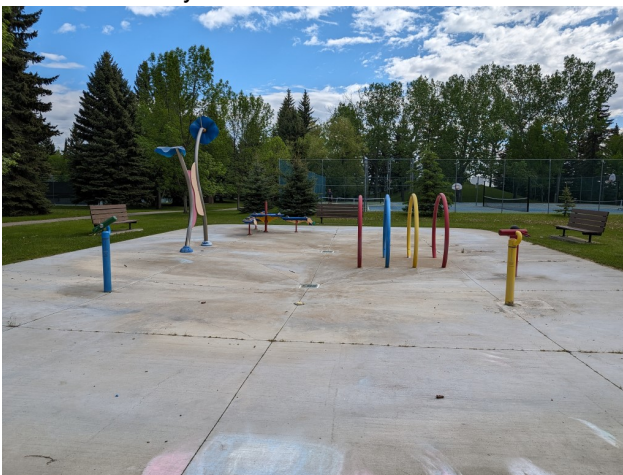
View of Spray Park

The spray park's overall condition is moderate. The equipment vault, along with its piping, valves, and manifold, are in good condition and have an expected lifespan of 8 to 15 years. The concrete pad is also in good condition. However, the water features are nearing the end of their typical 15-year lifespan. Currently, the spray park relies on the city water supply and directly drains to sanitary or storm services, leading to significant water costs. While full replacement is planned within the next 10 years, this timeline could be extended through ongoing maintenance, repairs, and replacement of failing components.

- **Concrete Pad:** The concrete pad is in moderate to good condition, exhibiting a broomed finish and slopes for drainage. Minor cracking is present, but structural integrity remains sound. Previous patching addressed sprinkler plumbing repairs. However, spalling, surface wear, and organic growth within expansion joints warrant attention. Removal of organics from the joints is recommended. Replacement is advisable concurrently with spray park equipment upgrades.

- **Water Piping & Water Features:** In fair condition, exhibiting corrosion and faded finishes requiring refinishing. Replacement is planned with an overall spray park upgrade.

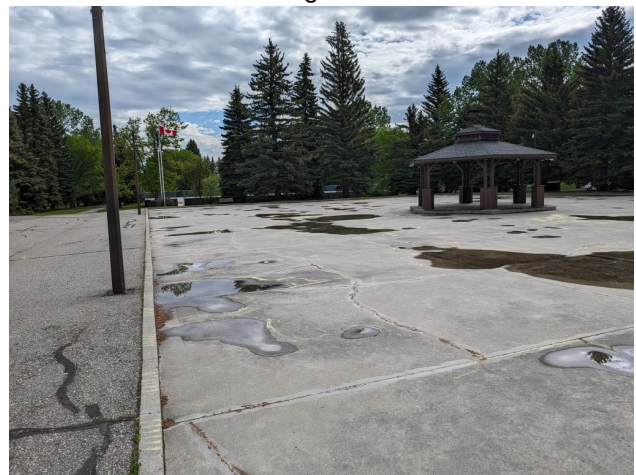
View of Concrete Rink

- **Concrete Flatwork:** The concrete slab on grade is in fair to poor condition, with deteriorating surfaces, cracking, ponding, and differential settlement. Previous crack repairs have since failed, and water infiltration through cracks may accelerate damage via erosion, hydro compaction, and frost action.
- An interim repair strategy is recommended to prolong the slab's serviceable lifespan. Uneven surfaces may not significantly hinder skating functionality for an extended period however, full replacement is ultimately inevitable and costly. Replacement timing should be strategically planned to maximize the existing slab's remaining lifespan while minimizing financial impact.
- **Concrete Curbs:** The edge curbs are in good condition and recommended for replacement concurrently with the concrete slab.

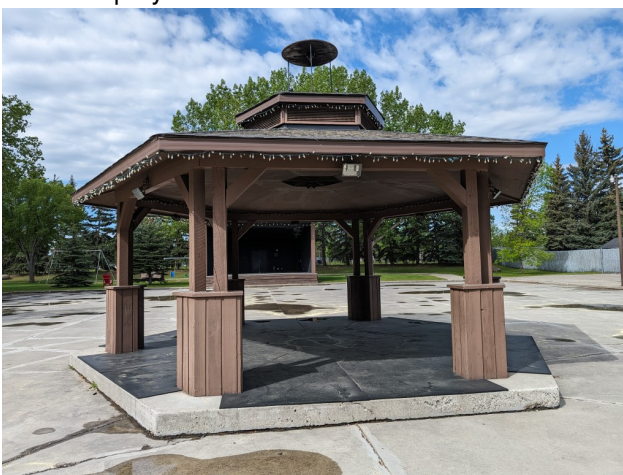
View of Gazebo

- **Concrete Pad:** The gazebo pad is raised above the ice slab, with observed sub-grade erosion under the slab. Filling gaps where the gazebo slab meets the rink slab should be completed and grade changes to the adjacent rink slab should modify drainage patterns away from the gazebo. While the pad appears sound, replacement should be considered during an overall rink and gazebo renovation.
- **Timber Framing:** In good condition requiring periodic refinishing and general maintenance. The timber framing should last upwards of 30 years if maintained.
- **Asphalt Shingles:** The asphalt shingles are in excellent condition. Typical lifespan of asphalt shingles is 20-30 years.
- **Trim Details and upper grills:** Serviceable but recommended for refinishing to extend their lifespan.

- **Soffit Ceiling:** Current plywood ceiling is in good condition, and is expected to last 10 years or more with regular refinishing.
- **Column Bases:** Timber shiplap is in contact with the concrete slab and is showing signs of rot, splitting, and finish degradation. Overall the shiplap bases are in poor condition and should be replaced during an overall gazebo renovation. Refinishing will extend their service life until then. Timber is a poor material selection for the column bases environment and a more durable product should be considered.

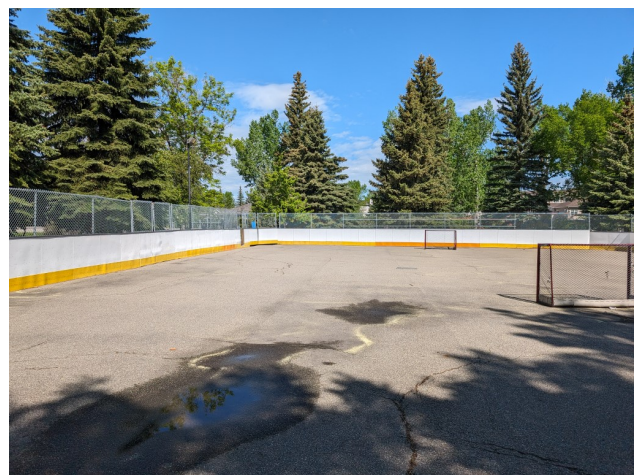
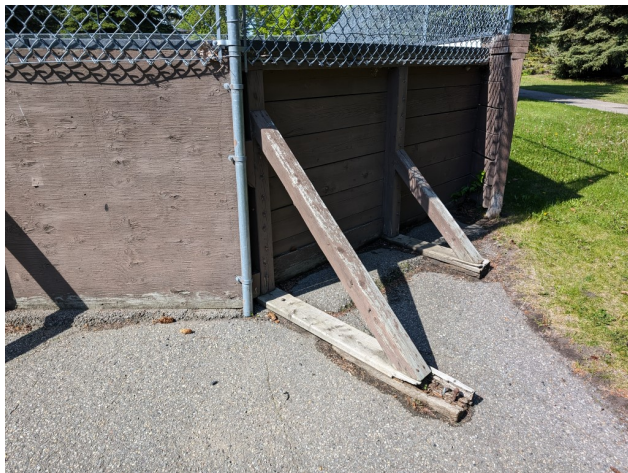
View of Hockey Rink

- **Asphalt Paving:** The rink's asphalt paving is in moderate condition, with cracking and ponding observed on the main surface. A separate asphalt surround supports the dasher boards and is in poor condition, exhibiting differential settlement and surface wear. Asphalt paving has a typical service life of 15-25 years. While the existing paving could suffice for several years given its primary function (supporting winter ice slab development), repairs or replacement should be timed with a solution for the dasher boards.

- **Dasher Boards:** The rink's current site-built dimensional wood and plywood dasher boards are showing signs of deterioration, including rot, fastener corrosion, cracking, and splitting. The safety and performance of the system is questionable and the condition is critical. A full replacement with a commercially available aluminum framed system is recommended for improved safety and longevity. A commercial dasher board system will typically last over 20 years.

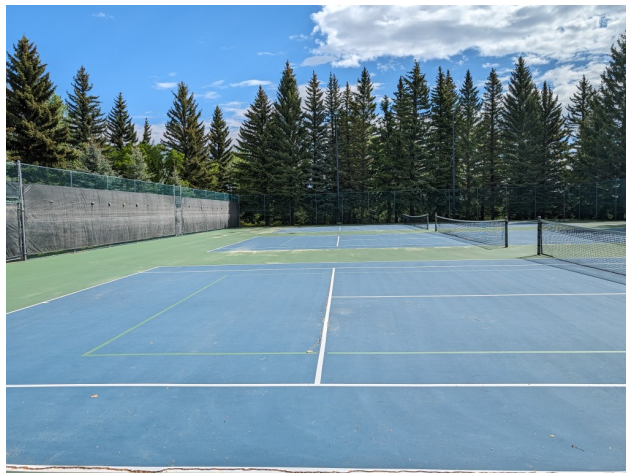
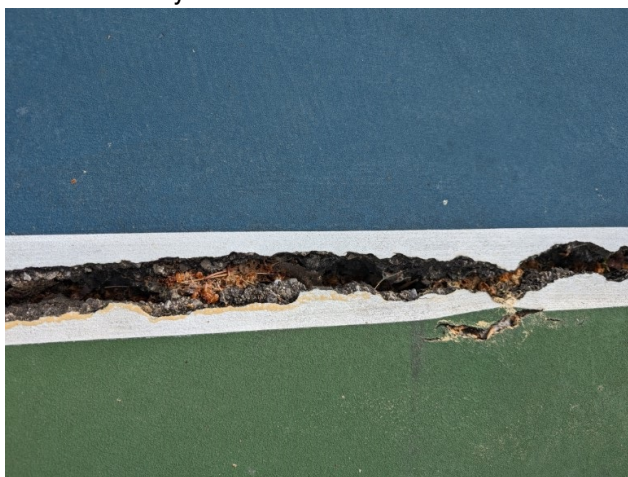
View of Tennis Courts

- **Asphalt Repair & Crack Control:** The tennis courts are built on an asphalt base that exhibits cracking on both courts. Court 1 is in generally fair condition, while Court 2 suffers from significant cracking in the base asphalt, leading to a poor overall condition. Immediate repair of these cracks is crucial to prevent further deterioration and mitigate potential trip hazards. Regular crack repair and resurfacing are recommended to extend the lifespan of the courts. Asphalt typically lasts 15-25 years. A resurfacing schedule within the next 5-10 years should be considered, allowing for subgrade repairs where possible. The impact of repairs, tolerance for degraded surfaces, and safety considerations will influence the specific timeline.

- **Refinishing & Markings:** The multi-layer acrylic surfacing is in good condition overall but should be patched after any cracked control measures. Acrylic tennis surfaces typically require resurfacing every 10 years.
